# Manhole Inspection Summary

Manhole # S15A\_\_021MH

**Location** Address: **REAR 2548 LANVALE**

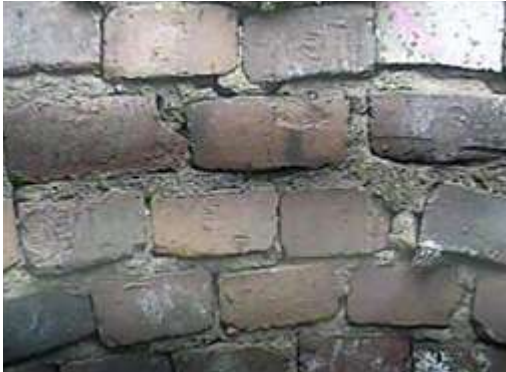
Defect 1

**Steps** Count: **4** Missing: **1** ☐ Corroded

MISSING CORRODED RUNG

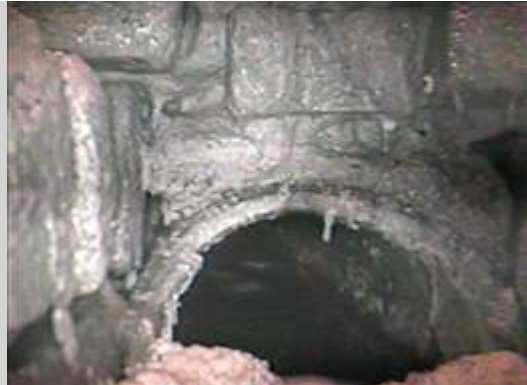
12 O'Clock Outflow

8 in. Circular Gravity Sewer  
Pipe Out @ 12 O'Clock

Pipe Height: (in.) Direct  
Pipe Material: **Clay** ☐ Pipe Lined  
Invert Depth: **10.23** (ft.) Flow Characteristics: **Slow**  
Deposits: ☒ None ☐ Mud ☐ Sludge ☐ Debris ☐ Grease  
Silt Depth: (in.) Deposits Extent:  
Infiltration: **None** Pipe Seal Cond: **Sound**

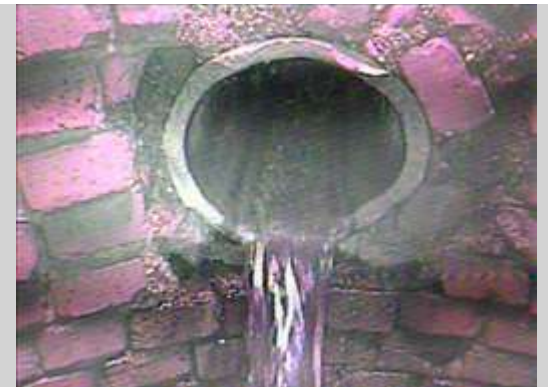
6 O'Clock Inflow

8 in. Circular Gravity Sewer  
Pipe In @ 6 O'Clock

MISSING CORRODED RUNG

Pipe Height: (in.) Direct  
Pipe Material: **Clay** ☐ Pipe Lined  
Invert Depth: **6.10** (ft.) Flow Characteristics: **Slow**  
Deposits: ☐ None ☐ Mud ☒ Sludge ☒ Debris ☒ Grease  
Silt Depth: **7** (in.) Deposits Extent: **Heavy**  
Infiltration: **None** Pipe Seal Cond: **Sound**

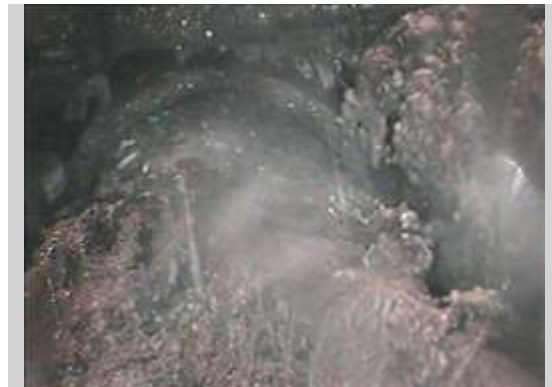
Drop In @ 6 O'Clock

PIPE CLOGGED

Drop: **Outside Direct**  
Angled: Reading: (ft.)  
Inv Depth: **10.10** (ft.)  
Drop Condition: **Clogged**

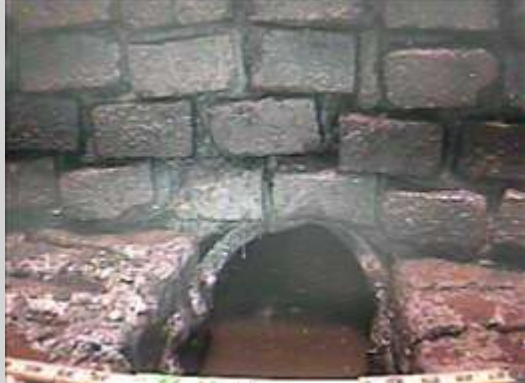
9 O'Clock Inflow

8 in. Circular Gravity Sewer

Pipe In @ 9 O'Clock

Invert Depth: **9.94** (ft.) Flow Characteristics: **Slow**

Deposits: ☒ None ☐ Mud ☐ Sludge ☐ Debris ☐ Grease
